AIR RESCUE REPORT

International Commission for Alpine Rescue

October 16-19, 2013 – Bol, Island of Brac – Croatia

ACCIDENTS & INCIDENT REVIEWS FROM MEMBER COUNTRIES

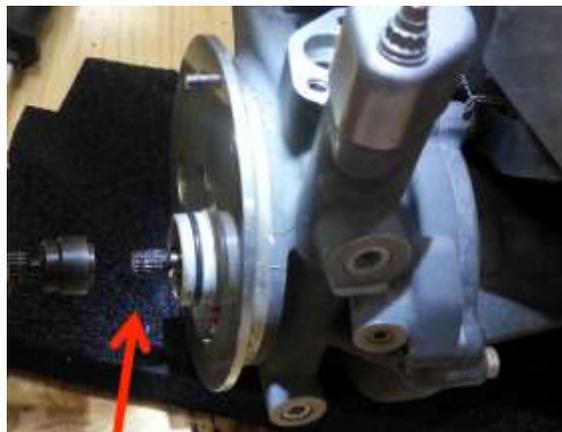
Austria-Engine Failure-Karlheinz Burtscher

OAMTC EC135T1, HEMS flight, start-up and pre take-off check was normal. Post take off normal until slight yaw with needle split and caution light. Engine failed during cruise flight. Declared emergency, performed a single engine emergency landing that was uneventful. On the ground restart, engine failed at 50% N1. Root cause- worn spline on the fuel pump drive system between the HMU and Reduction Gear Train.

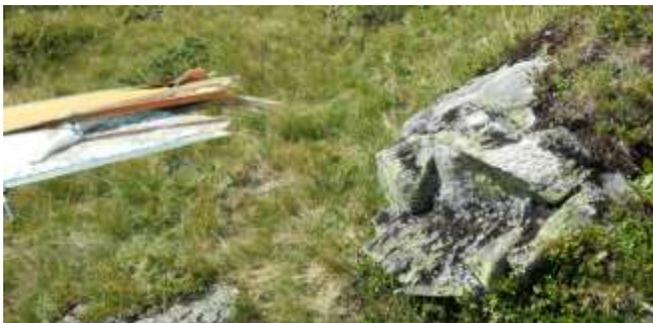
Austria-Main Rotor Blade Strike-Karlheinz Burtscher

OAMTC EC135, HEMS flight, Pilot had landed the helicopter on a narrow uphill path to drop of the HEMS crew. Pilot decided to reposition the helicopter with 120 degree turn to the right. HEMS crewmember was standing in front of the helicopter to guide the pilot via radio. During the maneuver the main rotor struck a rock that was outside the pilot's field of vision.

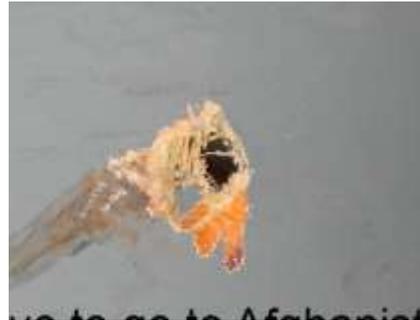
Austria-Blade Bullet Hole-Karlheinz Burtscher

During preflight a bullet hole was found in one of the main rotor blades.

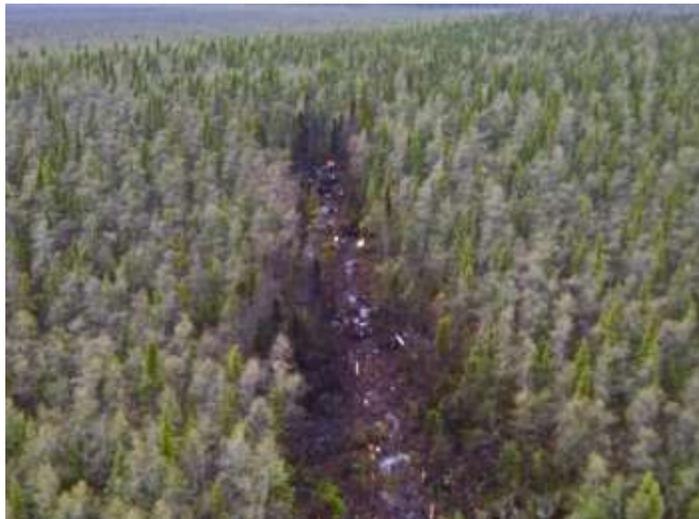
Canada-HEMS Accident-Brian Webster

Sikorsky S-76 crashed one minute after take-off from airport (1 km) during HEMS flight. All personnel (two pilots and two paramedics) killed. Weather was 3 degrees C, overcast and light rain. Time of crash was midnight. No NVG being used. SAR response came from armed forces base in Trenton (830 km away). Cause of crash unknown at this time.

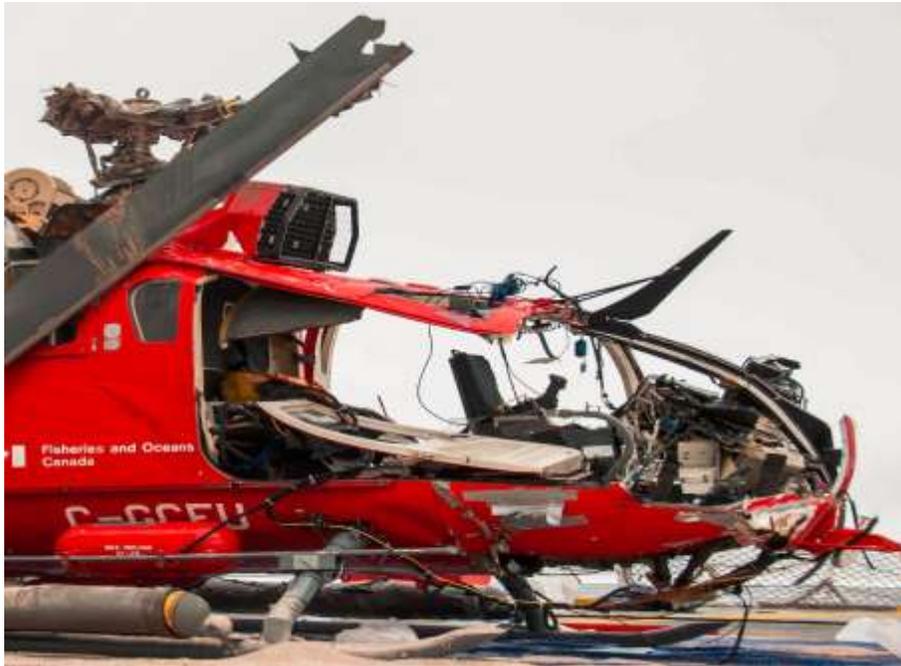
Canada-Accident-Brian Webster

Canadian Coast Guard BO105 (3 crew members, all fatalities) on ice research flight crashed through the ice. All crew members died due to hypothermia.

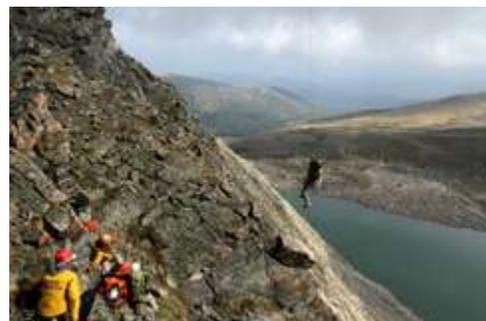
United States (Colorado)-Hoist Incident-Casey Ping

A Colorado National Guard UH-60 requested to extract patient that had fallen from Mount Bancroft. The patient was initially unconscious and became hypothermic while waiting for rescue. Mountain rescue personnel had been inserted by HEMS aircraft ~200m below the accident site. Hoist extrication was requested due to patient condition and difficult extrication in exposed terrain. The National Guardsman was being inserted via the Jungle Penetrator and sustained a fractured lower leg. The National Guardsman was able to assist with the litter extraction of the patient. Mountain rescue personnel were unaware of the injury until this point. The mountain rescue team was able to treat and splint the Guardsman which allowed him to be extricated via hoist.

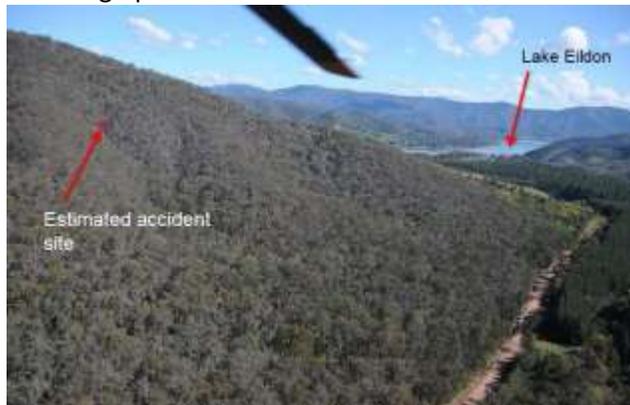
Australia-Hoist Accident-Casey Ping

The crew of a Bell 412EP helicopter was tasked to pick up a male patient who was reported to have fallen in the hills around Macs Cove, near Lake Eildon, Victoria (Vic.). The crew was informed that, due to the difficult terrain and the size of the patient, a winch extraction would likely be required. The patient was located in a heavily-wooded area in steep terrain about 1-1.5 km from the nearest road. The trees in the surrounding area were up to 60 ft. high and the crew noted numerous dead branches that could create a hazard for winching operations.

The crew located a suitable area into which to winch the paramedic to assess the patient's condition. They discussed likely retrieval options and decided that a stretcher winch would be too dangerous due to the steep terrain, surrounding vegetation and the possibility of fouling. Due to the small winch area and the possible fouling hazard, the crew elected for a double-lift extraction with the patient in a rescue/retrieval strop (strop). The paramedic and air crewman were unable to get the winch portable radio to work, so they decided that the paramedic would use hand signals to indicate whether a winch extraction would be required. On arrival, the crew noted that some trees had been cleared to create a larger winching area and that the patient had been moved to this area. After about 5 minutes the paramedic signaled to the crew that he was ready to winch and the crew positioned the helicopter over the winching area in an approximately 80 ft. hover, about 20 ft. above the tree canopy.

Initially, the winching procedure appeared to proceed normally. The air crewman reported that the paramedic appeared to have his arms and legs wrapped around the patient, as is the normal procedure. When the paramedic and patient were approximately 30–40 ft. above the ground, the air crewman noticed that they had moved towards the edge of the winch area and close to the upper branches of the trees. The paramedic stated that he came in contact with the branches and had to use both hands to fend off as he came through the tree canopy. The helicopter was moved back and right about 5 ft and the winch continued. The air crewman reported that once the paramedic and patient were clear of the canopy, at about 15 ft. below the aircraft, he noticed that the patient was moving or wriggling.

The air crewman stopped the winch for a control check, and shortly after resuming the winch, noticed that the patient's arms were not in the usual position in the strop and that the paramedic appeared to be shouting at the patient. The air crewman elected to continue winching in, and informed the pilot that the patient was slipping. As the paramedic and patient reached the height of the helicopter's right skid-landing gear, the paramedic was facing the helicopter and the patient was facing outwards. The paramedic reported attempting to pin the patient against the skid in an attempt to stop him slipping. The air crewman continued winching until the paramedic's head was level with the middle of the door opening. At this stage the air crewman informed the pilot that he could see the patient slipping further. He dropped the winch pendant and reached down, grabbing the patient's shoulder in an attempt to stop his fall. The air crewman stated that by this stage the patient appeared to be unresponsive and limp.

Despite the crew's efforts, the patient slipped out of the strop and fell to the ground, sustaining fatal injuries.
