AIR RESCUE REPORT

International Commission for Alpine Rescue

October 19 - 22, 2011 – Åre, Sweden

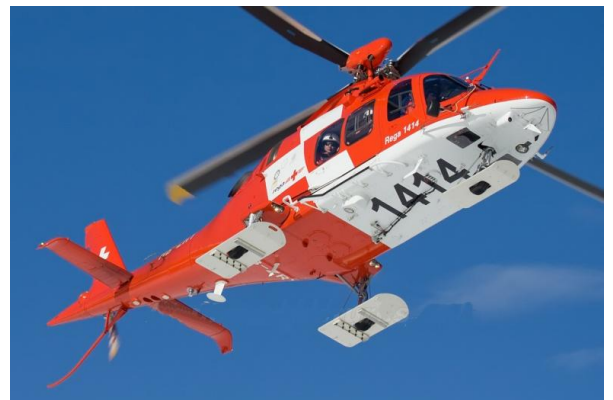
Switzerland, Hoisting incident

While hoisting an injured cyclist in treed terrain, the rotor wash caused a branch to break off a tree. The doctor was on the ground when the branch hit the patient furthering his injuries. The aircraft was an Augusta 109 DaVinci. Similar incidents have happened in the past particularly with the modern generation aircraft that are bigger and have more downwash. Discussion ensued on how best to protect patients or victims in these incidents including the option of using helmets. However, this can be contraindicated with head and spinal injuries.

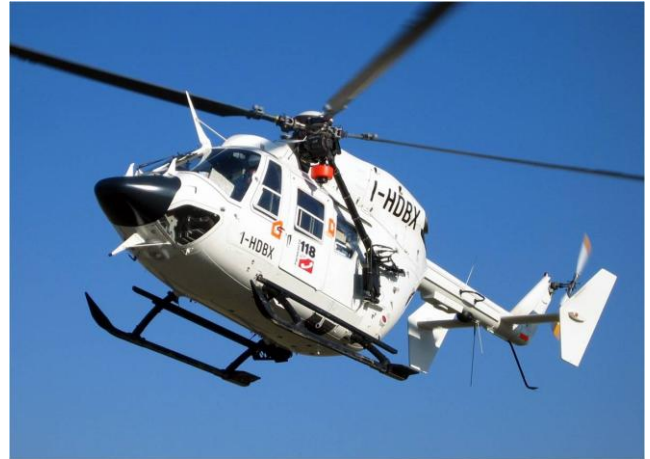
Italy, Hoisting incident

In June 2011, during a hoist deployment from 50 metres, two rescuers were preparing to descend. The HEMS aircraft, a BK117 C1 with a Goodrich hoist is based in Bolzano. They were attached to the hoist and the operator started to actuate the hoist. The cable cutoff function was triggered uncommanded. Fortunately, the rescuers who were standing on the skid, were still attached to a hard point inside the aircraft and did not fall out of the helicopter.

Subsequent investigation revealed a short circuit in the remote control handle and a short circuit as the cause. An

Airworthiness Directive was issued by EASA to deactivate this hoist type until the problem was solved and corrected.

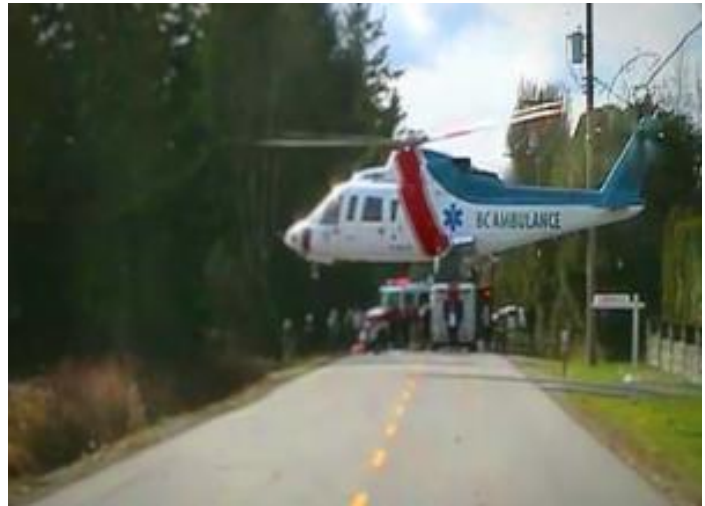
Canada, Cable strike

A Sikorsky 76 BC Air ambulance was loaded with a patient who had fallen roughly 15 feet into a water-filled ditch while pruning trees from a tractor bucket, injuring his back. The helicopter had landed on the road beside the accident site.

As the aircraft was departing, it turned to the left and as it started to gain altitude it struck overhead phone lines. The pilot apparently had not realized that as the aircraft was turning, it drifted to the right underneath the phone lines. The pilot was able to land uneventfully in a field beside the road where he had landed. The patient was taken to hospital by ground ambulance.

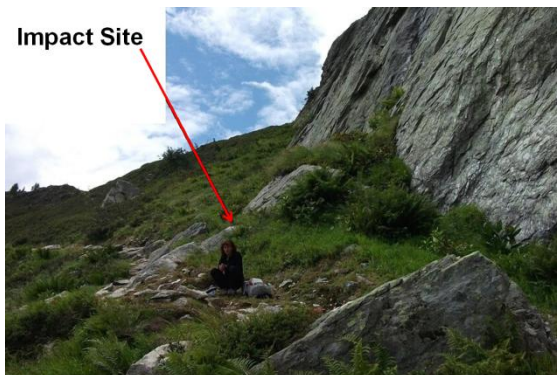
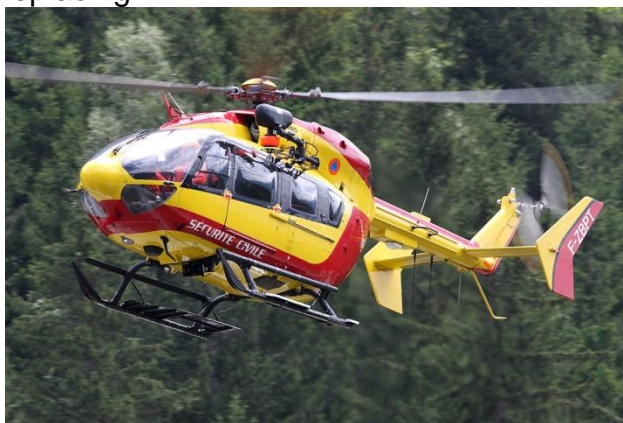
France, Rotor Strike

In July 2011, while picking up an injured hiker in a partial landing, an EC145 struck terrain with the main rotor blades. The site was on trail at 2134 metres in the Lac Blanc area of the Chamonix Valley. This toe-in landing involved an experienced crew who considered it a "simple" mission.

As the helicopter was lifting off the main blades struck terrain. As there was no place to land nearby, the pilot continued lifting and descended to the valley below. He was able to land uneventfully. The blades sustained significant damage and needed replacing.

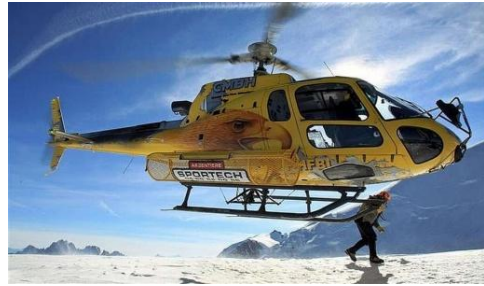
France- ACCIDENT

A Eurocopter AS350 B3 helicopter from Chamonix Mount Blanc Helicopter crashed on September 14th after a collision with a wire. All four occupants were killed. The machine crashed near the French-Swiss Border on a power line control flight and was caught fire following the accident. The pilot was a well experienced pilot and also mountain guide.

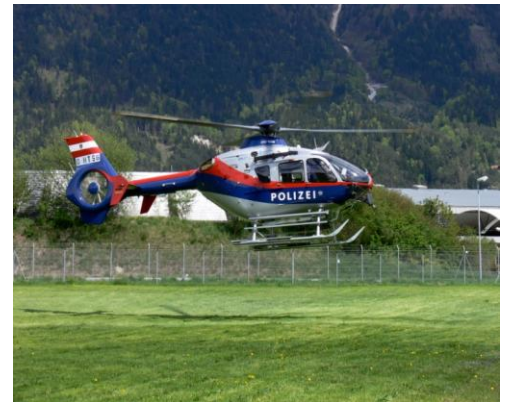
Austria - Crash

On March 30, 2011 during forward flight an EC 135 impacted into Lake Achensee in Tyrol, 40 km east of Innsbruck, at high speed. All four crew members on board died. The recovery efforts took four days with many rescuers and divers. This is a deep lake and the crew and helicopter were recovered at a depth of 100 metres. The weather at the time of the accident was clear and calm. The accident is still under investigation but so far no causes have been determined. The pilot was reported to have 2,500 flight hours and the aircraft was relatively new with only 1300 flight hours.

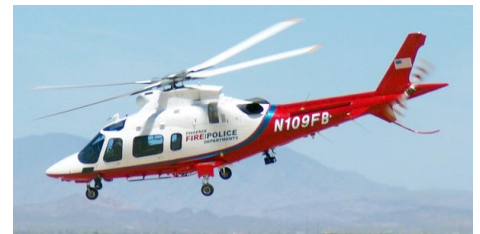
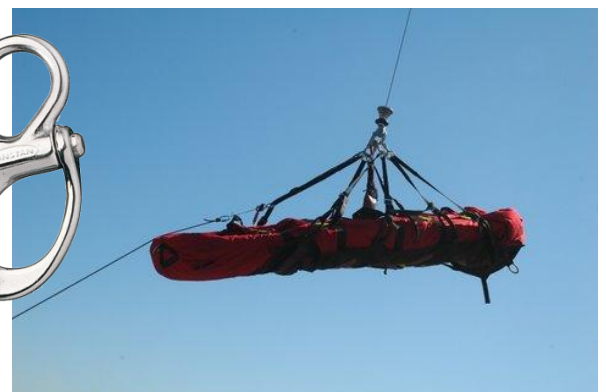
United States (Arizona)- LITTER SPINNING INCIDENT

The Phoenix Police Department- Air Support Unit experienced a severe litter spinning event during a helicopter hoisting operation on December 22, 2010. Following a fall on Piastewa Peak, a 52-year-old hiker suffering neck and back pain, was packaged in a Stokes litter inside a Bauman Bag for a hoist extraction with an A109 Power helicopter.

The stationary hoisting evolution was performed from an altitude of 200 ft (61 m) AGL with a 250 foot (76 m) tag line tended by a ground rescuer. The

patient had been packaged in a Stokes Litter which was placed inside a Bauman Bag. No attendant is employed due to the decreased hoist speed. The tagline was connected into the master attachment point of the Bauman Bag and the normal procedure involved having the aircraft remain directly overhead. This orientation permitted the tagline to block the litter from spinning. On this date the aircraft moved laterally away from the scene causing the tagline to be at an acute angle and spinning of the litter quickly developed. The spinning became severe to the point that the hoist evolution could not initially be completed safely.

Following this event, agency personnel evaluated the connection point configuration and made a modification for placement along a support strand of the Bauman Bag reaching down to the foot end of the litter. The revised connection includes the use of a shackle quick release along with an in-line breakaway weak link.

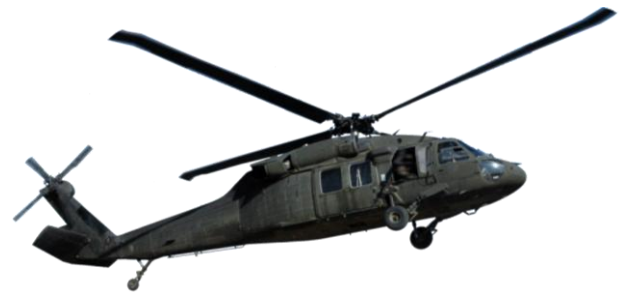
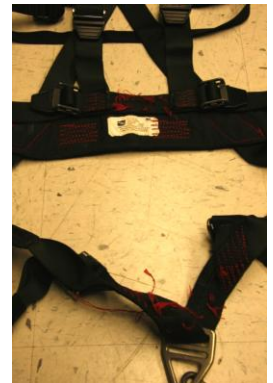
United States (Texas) - HOIST TRAINING INCIDENT

During a tree hoist rescue training exercise in Travis County, Texas on July 24, 2009 a rescuer was involved in an incident which dramatically damaged their harness. The exercise was being conducted with members of Texas Task Force-1 and a National Guard UH-60 to simulate hoist rescue operations of subjects from trees during extreme seasonal flooding conditions. During a hoist extraction of a rescuer along with a “victim” in a rescue stop the helicopter drifted forward causing a tree branch to become positioned between the rescuer and hoist cable. As the hoist extraction proceeded, the branch tore downward at the harness connection point. The full body rescue harness partially failed causing the rescuer to become inverted. The training evolution was completed without further incident or injury.

In post analysis of this exercise, the following “best practices” for tree hoisting operations were compiled:

- Employ a slow and methodical approach to permit adequate decision-making and mission planning. Review exact route and landmarks
- During approach over the scene the crew chief and rescuer should take the opportunity to communicate a very detailed rescue and access plan
- Establish a hover at 100-120 ft (30-36m) permitting rotor wash to open tree canopy
- Do not permit cable slack to develop to the rescuer which would create entanglement
- The extraction should be planned and slow, since there is no returning a rescuer to a branch once airborne
- Finally, manage all aircraft drift immediately

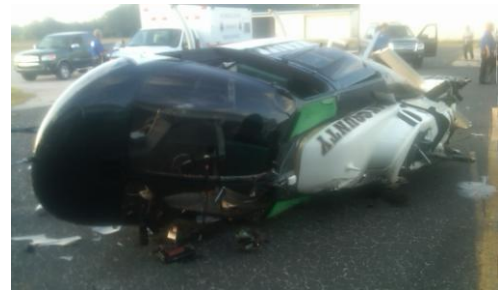
United States (Florida) - ACCIDENT

On May 27, 2011 the Bay County Sheriff's Department (Florida) experienced the crash of a department OH-58 (military version of Bell 206A Jet Ranger) during a search incident response. The aircraft was preparing to depart for a missing persons search from a hangar at the recently-closed Panama City-Bay County International Airport (PFN), Panama City, Florida. The helicopter was temporarily housed in a large hangar, and ground support equipment, including wheel dollies, had been moved to the unit's new location at a new airport. The helicopter had flown in and out of the hangar on numerous occasions; however, during the accident flight, while attempting to depart from inside the hangar, hangar ceiling tiles dislodged and went through the main rotor system. The pilot lost control and the helicopter impacted the ground.

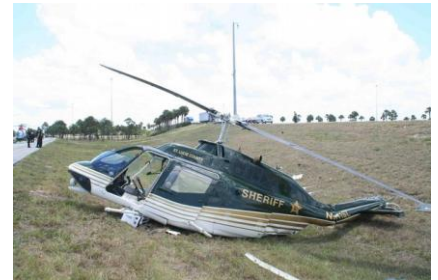
United States (Florida) - ACCIDENT

Two days later, on May 29, 2011, another OH-58 crash was experienced by the St. Lucie County Sheriff's Department (Florida) during a search operation in Fort Pierce, Florida. The helicopter was called to assist in a search for a possible ejected passenger from a vehicle that was involved in a rollover accident near a highway on ramp. The helicopter was about 300 feet (91m) above ground level (AGL) when it climbed in a southeast direction to about 400 feet AGL (122m). As the helicopter was heading back to the north-northwest, it began to spin as the nose went up and down. It continued to spin and finally dropped on its skids in the grass median between the highway and the on ramp. The pilot received minor injuries and the helicopter incurred substantial damage.

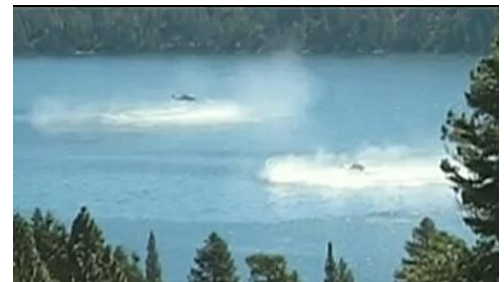
United States (California) NEAR-MISS INCIDENT

The U.S. Navy grounded two pilots and investigated a near-miss at Lake Tahoe (CA) following the release of civilian cell phone video footage taken on September 13, 2011. The video shows two MH-60 Romeo helicopters close to the water when one dangerously dips into the lake (see YouTube- "New Detail From Choppers' Dip in Lake Tahoe NBC Bay Area"). The helicopters, based at Naval Air Station North Island (San Diego, CA), were returning from an air show near Sacramento. Lake Tahoe is not on the direct route between Sacramento and San Diego. Following the incident the aircraft landed at the Lake Tahoe Airport and the involved crew flew home via commercial air transport. Although not specifically rescue related, the incident reinforces the need to avoid deviating from the planned mission.

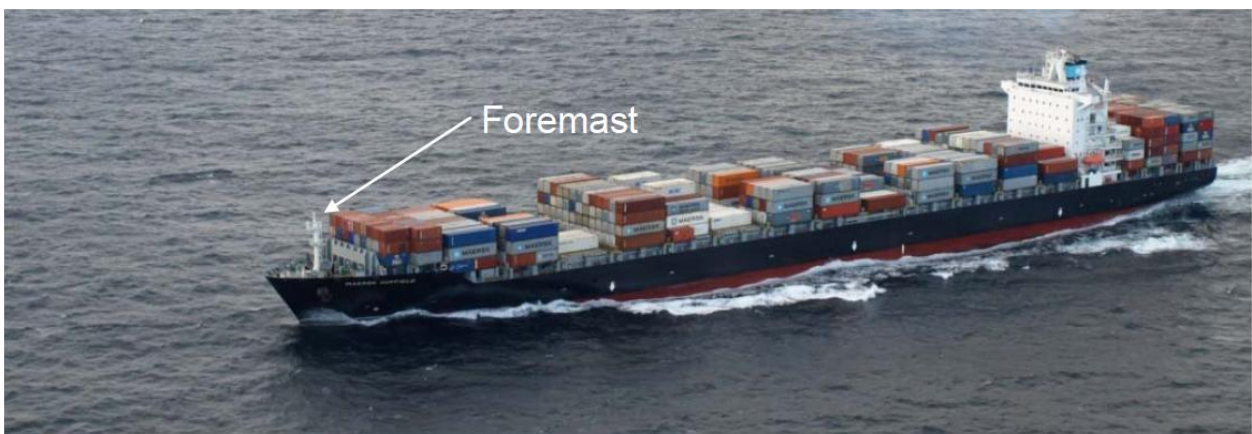
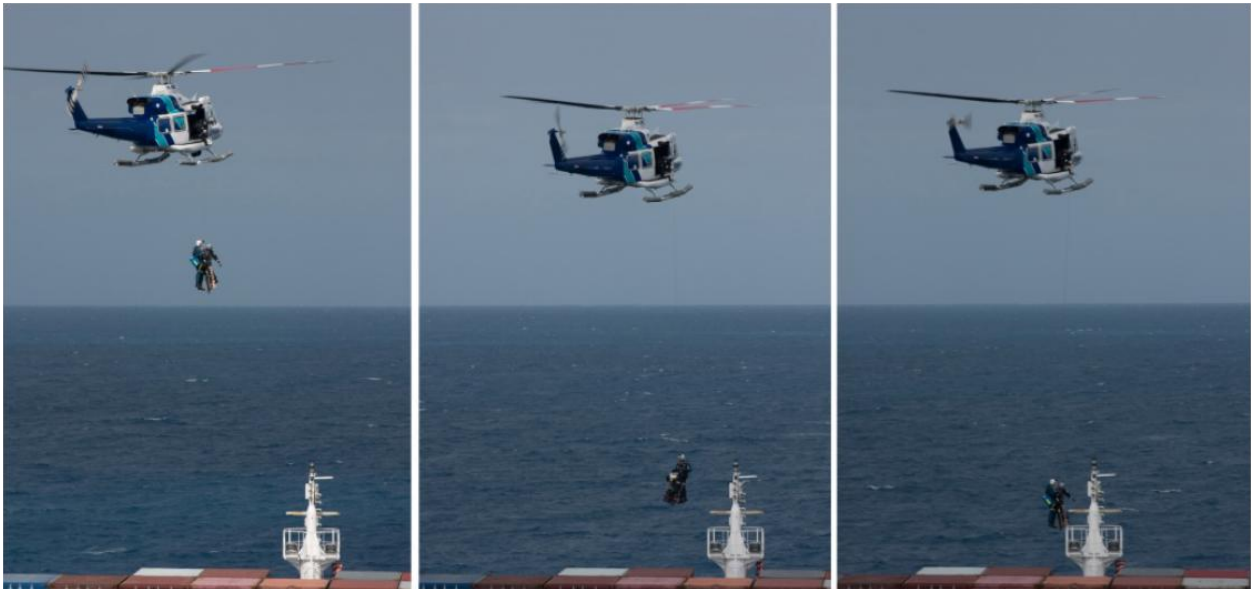
Australia (Queensland) - HOIST ACCIDENT REPORT RELEASED

The Australian Transport Safety Bureau released a final investigative report regarding the November 9, 2009 hoisting accident. This accident seriously injured two crew members, when the hoist cable failed and they fell approximately 50 ft (16 m) onto deck of the ship. The event occurred when a Bell 412 operated by Torres Strait Ambulance rendezvoused with a container ship (Maersk Duffield) to evacuate an ill crew member.

The rescue involved conducting the hoist operation from near the forecastle mast on the bow of the vessel. As the rescue crew officer (RCO) and paramedic were lowered by, the pilot lost sight of the ship. Shortly after, the helicopter began

drifting back towards a mast that was located on the forecastle. Despite assistance from the hoist operator to re-establish the hover, the pilot was unable to arrest the helicopter's movement and the hoist cable became fouled while the helicopter continued to drift rearwards. The winch cable separated.

The investigation identified that the requirement to confirm adequate hover reference existed overhead an intended hoist area, before deploying personnel on the hoist, was left to the pilot's discretion. In this instance the pilot, despite his extensive experience, did not identify the possibility of losing sight of the ship, and therefore the necessary hover reference. No formal risk assessment of the proposed task was conducted, although the potential hazards associated with the movement of the ship were considered during the planning.

Additionally it was found that the failure of the cable appeared to have occurred below its rated strength. The investigative report stated that the, "combination of abrasion and bending may have contributed to the separation of the cable at a load below the static load required to activate the overload clutch."

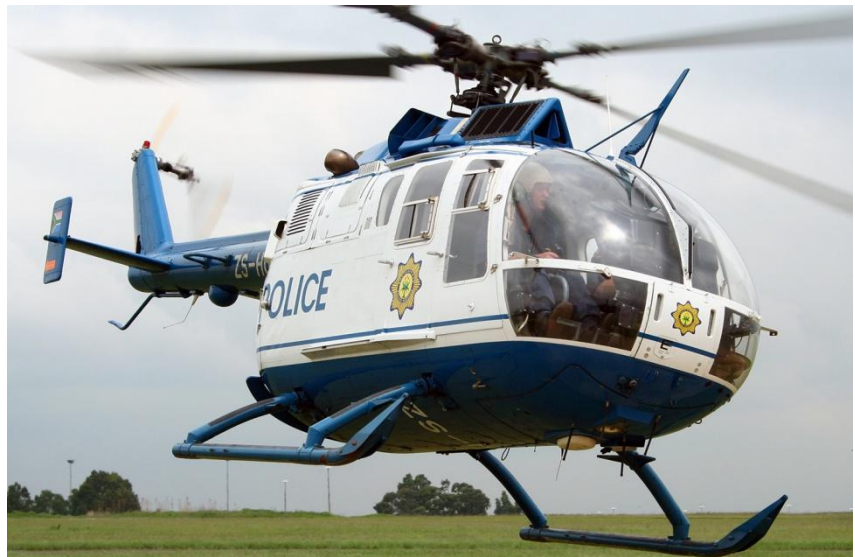
South Africa- Uncommanded Jettison of Short-Haul Load

A police rescuer fell five-six feet (1.5-2 m) during a January 2011 helicopter short-haul extraction. The Incident occurred during a body recovery operation being conducted by the South African Police with a BO-105 helicopter. This mechanical “uncommanded jettison” was caused by the pilot’s cargo hook foot release not automatically returning to the locked position. This mechanism requires that it be manually reset.

A decision was made to short-haul the police officer from the accident scene before returning for the body. The load was lifted five-six feet (1.5-2 m) and a power check completed. At the precise moment that the pilot began to continue the lift, the hook mechanism opened and dropped the officer back to the ground. The cargo hook's release mechanism requires a physical re-cocking action in order to properly engage the lock. This re-cocking action had not occurred, but the cargo hook appeared to be in the locked position when the short-haul line system was connected, however it was not. There was at least one other similar incident of uncommanded jettison before the load was lifted that occurred as well. The agency issued a warning notice on the incident.
