AIR RESCUE REPORT

International Commission for Alpine Rescue

October 2 - 7, 2012 – Krynica, Poland

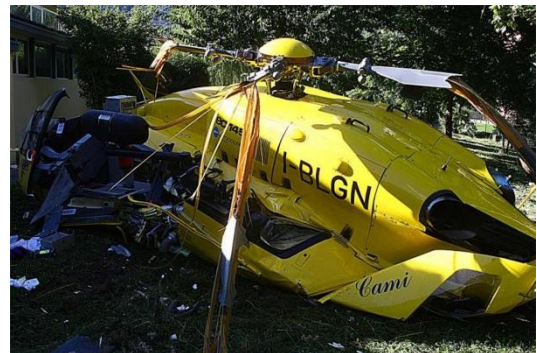
Italy, EC145, wire strike, crash

During takeoff, a HEMS helicopter struck wires and crashed. The crew of two (pilot and engineer) were only slightly injured. The helicopter was destroyed.

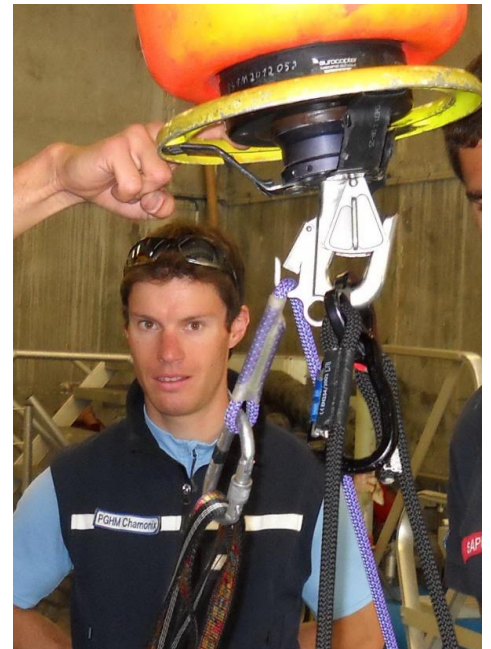
France, EC145, entanglement, near miss

During a hoisting operation at about 3500 metres late in the day (9PM), 3 exhausted climbers were being evacuated from the Gervasutti Ridge of the Tacul North Face. One rescuer was hoisted down to the anchor consisting of slings wrapped around a horn. The plan was to hoist two people at a time and ferry them to the cold du Midi below where one other rescuer had been dropped off. When the first two people were hoisted up, the leashes from the other two climbers got caught on the secondary hook of the Goodrich hoist. The anchor slings were lifted up and all four people ended up hanging on the hoist. Given the elevation and power requirements, the pilot was unable to maintain a hover. He was faced with either trying to take get all four people down safely or jettisoning the load. He was able to get all four down to the col and land without further incident. The hoist and engine limits were exceeded but no damage ensued. There was a lot of discussion on entanglement issues and how to prevent them.

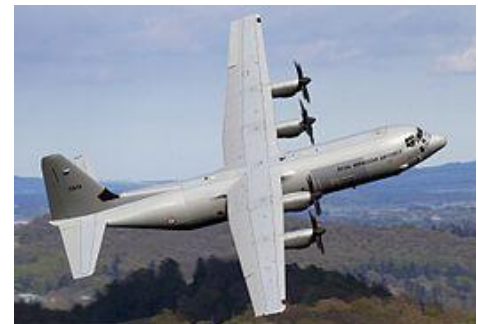
Norway, C-130, crash

Although this was not a helicopter crash, it is noteworthy because of the scale of the response. This was a major search with joint coordination between Sweden and Norway. A C130, Super Hercules of the Norwegian Air Force was dispatched while participating in a military exercise. The aircraft disappeared from radar over the Kebnekaise mountain range near Kiruna, northern Sweden. A major search was undertaken with over 100 searchers, snowmobilers and skiers. After three days of searching in poor weather, the wreckage was found by another P3-Orion fixed wing aircraft. Initial attempts to access the site by Danish helicopters, one Norwegian Sea King and two Swedish helicopters were unsuccessful due to weather. Some of the remains were eventually recovered including the cockpit voice recorder. All five crew members on board were killed. The incident is still under investigation.

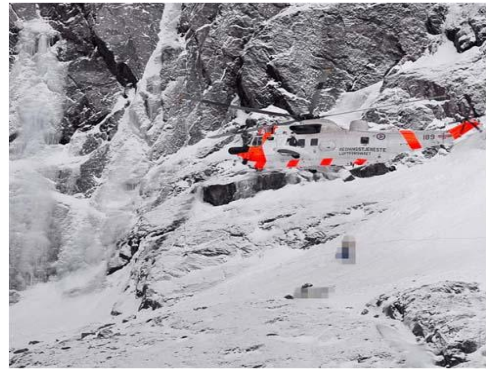
Norway, Sea King, jettison of hoist cable.

During a complex rescue for two missing ice climbers, the Sea King crew cut the cable during an attempt at a hoist extraction. When the accident site was found, it was determined that the climbing party had been hit by massive Rockfall. They were located at the base of the waterfall and presumed deceased. Due to the steepness of the terrain and the risk of further Rockfall and icefall, rescuers were hoisted a few hundred metres below. They then climbed in to the accident site. A super long line extraction using the two hoists on board and with ropes rigged at the accident site was attempted. One victim (deceased) was in the stretcher but not yet attached to the helicopter. As the helicopter was hovering, the cloud base descended and enveloped the cockpit. The hoist hook had been lowered. The crew cut the cable and descended to the left in IFR conditions. The aircraft was able to land safely. The recovery was completed the following day in good weather.

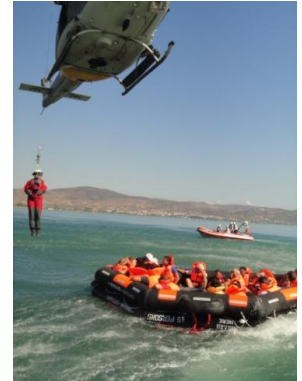
Greece, BH205, hoist cable failure

During a hoisting exercise over a small vessel, the cable on the hoist failed as the rescuer was just above the vessel. There were no injuries. The cause of the hoist failure is unknown.

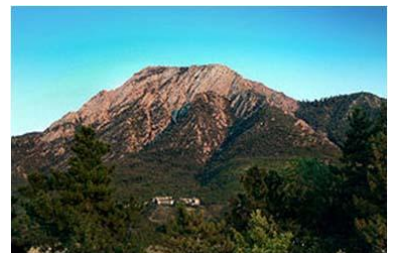
United States of America, AS350B2, Crew fatality

A rescue crew with the department of public safety responded to injured hikers on the Mt. Olympus trail near Salt Lake City, Utah. The aircraft was unable to lift off with the whole crew and the victims. Tactical flight Officer Aaron Beesley was left at the scene and was to be picked up on a second evolution. When the crew returned he was found deceased at the bottom of a 20 metre cliff. It is speculated that he fell while trying to retrieve a pack.

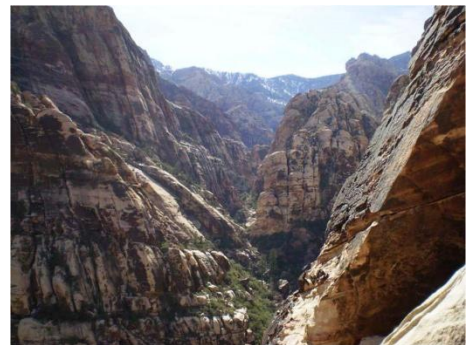
United States of America, Bell HH-1H, rotor strike

A crew from Las Vegas Metro Police Aviation was evacuating stranded hikers from a canyon during a training for SAR personnel. The first evolution was done with a toe in. Upon returning, due to changing winds and the aircraft running out of left pedal, the pilot elected to perform a one skid landing on the right. Upon departure, the main rotor blades struck the ground but he was able to fly away without further incident. Crew Chief fatigue may have been a factor.

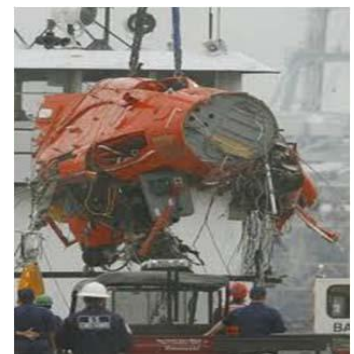
United States of America, AS365, Crash

During a US Coast Guard training mission off the coast of Alabama, the crew encountered poor visibility resulting in the pilot losing reference. As he turned to the right to try and regain reference, he impacted the water. It is estimated that the helicopter impacted the water at 70 knots from 200 feet AGL with a descent rate of 1500 FPM.

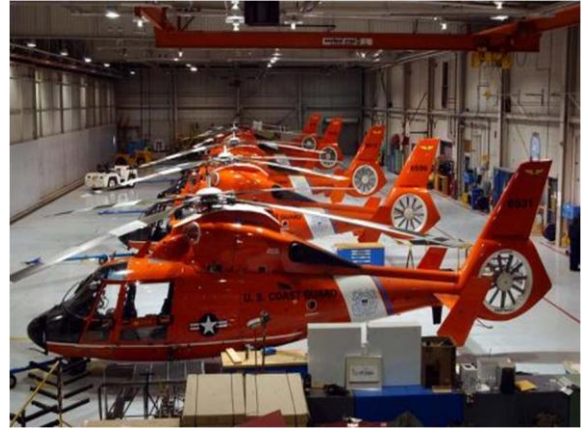
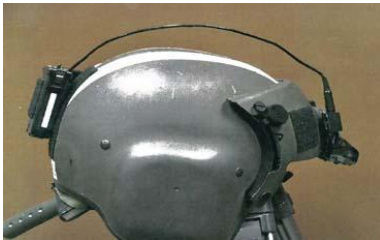
United States of America, AS365,

While responding to a victim in the water near Los Angeles California, a US Coast Guard helicopter had the number one engine shut down after establishing a hover. The pilot in command immediately initiated one engine inoperative (OEI) procedures and was able to transition to forward flight. The Co-Pilot initiated a restart of the #1 engine and the crew flew successfully to local airport. The engine shut down was initiated by the Co-pilots NVG cord on the helmet getting caught in the engine control switch.

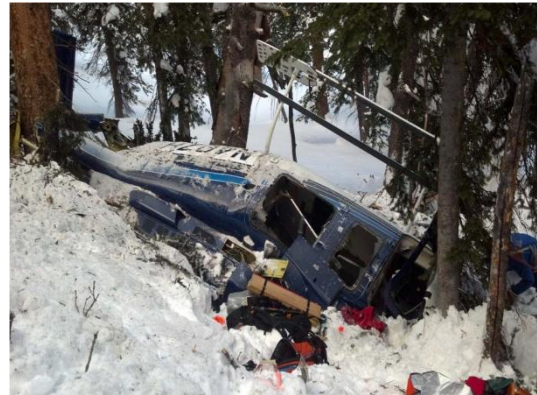
United States of America, BH 407, crash

During an operation for injured snowmobiler, a crew of three aboard the contracted Teton County Wyoming SAR helicopter crashed. As the pilot was establishing a hover, he experienced an unexpected yaw which he thought he corrected. The helicopter then began to spin rapidly and crashed into the trees below. The pilot was able to get out and crawl to a ridge to call for help. One of the other crew members was injured and one was killed in the crash. Due to communication issues, it took 75 minutes for help to get to the crash scene.

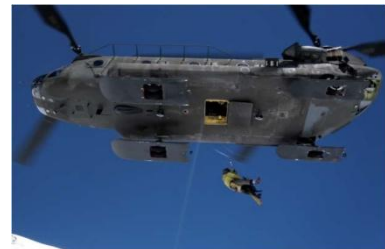
United States of America, Boeing Chinook, rescuer fatality

During the rescue of 4 injured climbers on Mt. Rainier in Washington, a rescuer fell 2400 feet to his death. The climbing party of four had sustained a fall on steep ice. After hoisting of the first victim, the helicopter was delivering a stretcher for the second victim. The rescuer went to receive the litter and it is believed that the rotor wash knocked him off balance.

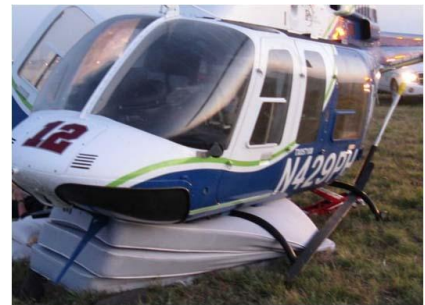
**United States of America, BH407, near miss**

During a HEMS mission in San Antonio Texas, the helicopter struck a tower and sustained substantial damage to the landing gear. The pilot requested an emergency landing at the hospital on top of mattresses but was denied. This procedure was done in a nearby field and the helicopter landed safely.
