AIR RESCUE REPORT

International Commission for Alpine Rescue

September 23 - 26, 2009 - Zermatt – Switzerland

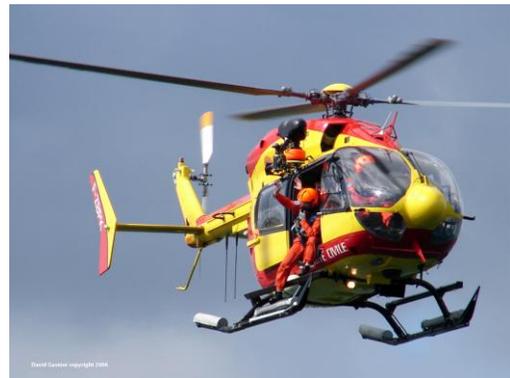
France – Crash. While performing a night-time medevac in Corsica an EC145 of the Sécurité Civile crashed. The aircraft was flying with the flight management system to Bastia. The pilot encountered reduced visibility and while reducing air speed struck a ridge. The crew and the patient (a pregnant woman) died in the crash.

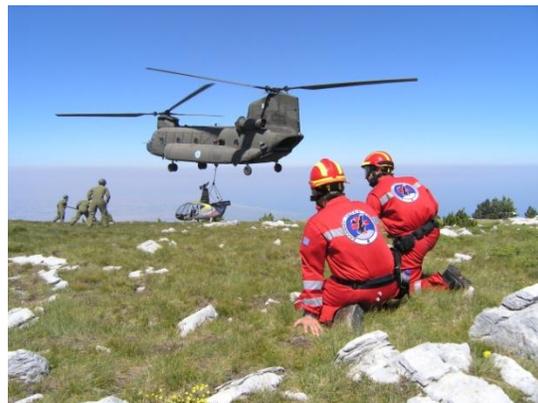
Greece-Crash. A Robinson R44 crashed while accessing a rescue site. None of the crew were severely injured in the crash. The wreckage was removed with a military Chinook.

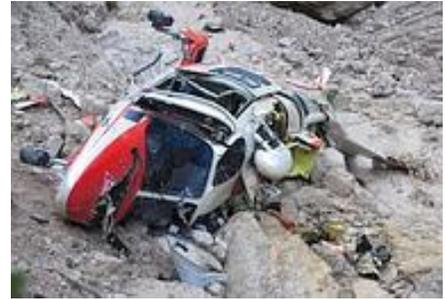
Italy-Cable strike A109

While investigating a landslide for victims near Belluno, an A109 struck cables spanning the valley. The aircraft crashed and all four occupants on board died.

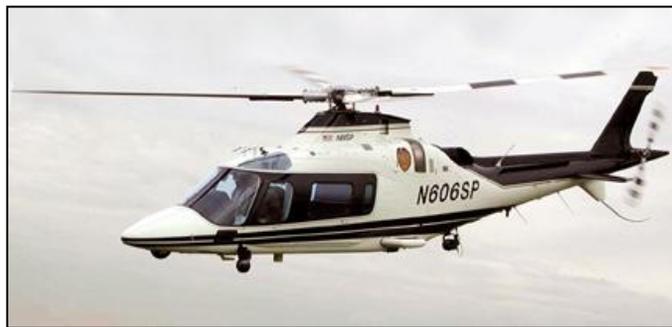
United States (New Mexico) - Accident

On June 9, 2009 a New Mexico State Police Agusta A109E crashed during the attempted rescue of an uninjured hiker near Santa Fe Baldy Peak 12,632 feet (3,850 m) near Santa Fe, New Mexico.

Instrument meteorological conditions prevailed when the helicopter impacted terrain, killing the 46 year-old pilot and female subject. The pilot and police spotter had landed after locating the search subject just before dark. Dispatchers had directed the helicopter crew to the missing hiker, as they spoke with her by cell phone. While the pilot hiked off from the landing zone to reach the subject, the weather deteriorated and began sleeting. The pilot returned carrying the hiker on his back. After becoming airborne, storm clouds closed in around the helicopter. Based on radio transmissions, the pilot reported "we hit a mountain," and continued to fly for at least one minute. The helicopter impacted terrain and rolled 800 feet down a steep talus slope. The deteriorating weather conditions were known in advance and the helicopter response lacked a formal mission briefing between all personnel involved. The incident commander had not dispatched and was not in operational control of the helicopter during the mission. The flight crew was not prepared with adequate survival equipment to remain at the landing zone overnight. A late season snowstorm hampered rescue efforts and the spotter, who was the sole survivor, was not located until the following day.

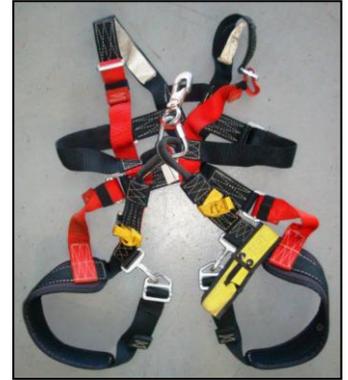
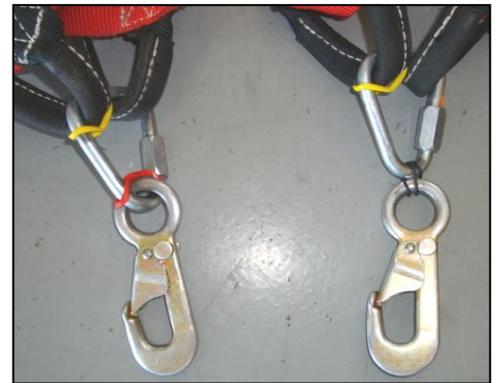
United States (California) – Heli-Rappel Accident

A 20 year-old US Forest Service Firefighter died on July 21, 2009, when he fell 200 feet during a proficiency heli-rappel training session. The incident occurred during the 6,000 plus acre (2428 hectare) Backbone Fire on the Shasta-Trinity National Forest (CA). The accident occurred during the initial load of rappellers for the training exercise. Personnel were on board the Bell 212 helicopter on the ground, with the engine running, while safety checks were completed. During the safety check, it was observed that the involved firefighter was missing an elastic O-ring keeper within the triangular screw link on his harness. The screw link is the connection point on the rappeller's WBBH-HR-2 Harness to a spring-loaded locking "J-hook", which is ultimately connected to the Sky Genie descender on the rappel line. The firefighter left the aircraft and got his harness reconfigured with the missing O-ring. The O-ring was tragically configured in such a manner that it created the sole connection between the triangular screw link and the "J-hook". The training exercise proceeded without the improper rigging being detected. The aircraft was stabilized in a 200 foot hover, away from other aircraft at the helibase. As the involved firefighter leaned back and loaded his harness, the connection created by the lightweight O-ring failed, causing him to fall un-arrested to the ground below. The aircraft landed immediately, and following resuscitation attempts, the firefighter was pronounced dead at the scene.

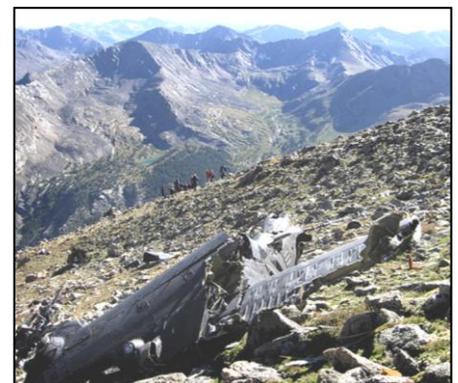
United States (Colorado) – Accident

Four soldiers died on August 19, 2009 after a Black Hawk helicopter crashed 400 feet (122 m) below the summit of Colorado's 14,421-foot (4,396 m) Mount Massive, during a training mission. The high-altitude training began from Peterson Air Force Base in Colorado Springs, which is 90 miles (145 km) east of Mount Massive. The helicopter was assigned to the 160th Special Operations Aviation Regiment (Airborne) at Fort Campbell, KY. Soldiers in the 160th are known as "Night Stalkers" because they specialize in nighttime operations. A trail crew working nearby witnessed the aircraft descend and impact a ridgeline. Two crew members were ejected from the wreckage as it rolled down the mountain. Prevailing weather conditions reported 4,000 feet lower than the crash weren't unusual for the mountains with temperatures in the 60s and winds gusting up to 26 mph. The entire inter-agency response, recovery, investigation and salvage at the high altitude site took a total of eight days. The Black Hawk's flight recorder was recovered and military investigators from Fort Rucker, AL are examining the accident.

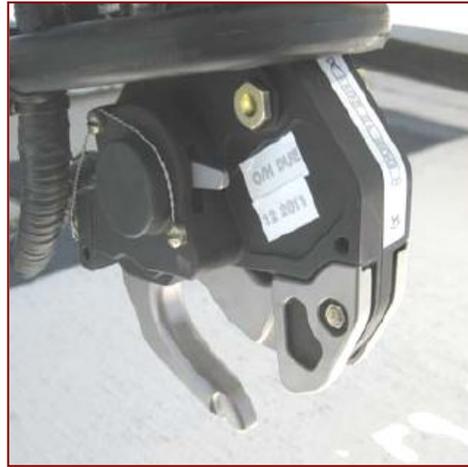
United States (Wyoming) - Inadvertent Short-Haul Hook Release

During a helicopter short-haul training session on July 9, 2009 at Grand Teton National Park an inadvertent release occurred of the primary anchor point, which is a Talon Keeperless Cargo Hook (manufactured by Onboard Systems). During this release, with a suspended human load, the backup anchor point, a three-ring release system, caught load as designed. Prior to the mishap, the involved Eurocopter AS 350 helicopter was returning from refueling and the spotter observed the short-haul rope had released from the cargo hook and was held by the backup “three-ring”

system. Subsequently the equipment was inspected and tested with training resumed. During the training exercise, with a human load suspended 10 feet AGL, the primary anchor (cargo hook) experienced an inadvertent release. The release shifted the load to the secondary anchor (three ring release). Following the release from the primary hook, the litter and attendant began to spin. Several attempts were made by the attendant to slow the rate of spin, but with only limited success. The litter and attendant were immediately returned to staging site. Subsequent investigation noted damage on the outer sheath of the manual release cable. With the manual release mechanism cover removed, the rigging of the fore and aft cables could be measured. The manual release cable to the cargo hook had approximately ¼ inch (0.6 cm) of the movement necessary to effect a mechanical release when connected. Any bending of forward cable, such as when the collective is raised, causes an effective “shortening” of the inner cable. Unlike conventional hooks which reset themselves, Talon Keeperless Hook must be manually re-cocked. Rigging of the release cables should be done with hook open and minimum clearance in system. Closing and latching hook eliminates clearance and pre-loads release trigger.

1. Check clearance between end of the inner cable and end of the outer sheath.
2. Check clearance between the guide on forward cable and end of the aft cable.
3. Check general cleanliness and condition of the release cable.

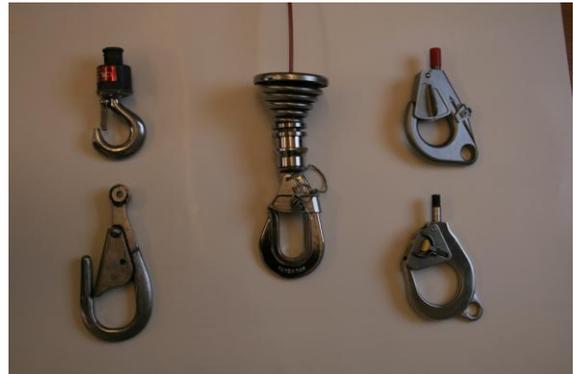
Rescue Hoists-Geoff Dinsdale, Breeze eastern UK.

A number of near miss incidents were described involving cable strikes against aircraft fuselage. It was reiterated that abseiling from the hoist hook is a dangerous practice not supported by the manufacturer. A number of different hooks were shown and the manufacturer is trying to come up with hook designs that will preclude the possibility of rollout.

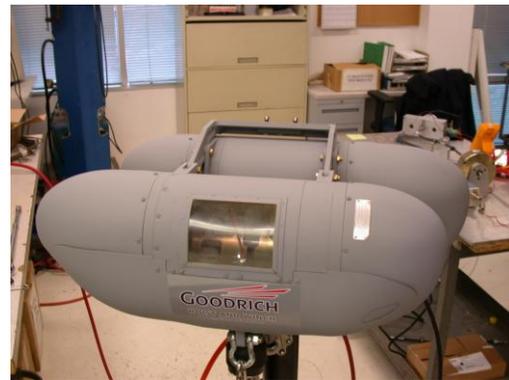
Rescue Hoists-Goodrich Hoists, Bob Strickland, USA.

This presentation focused on incidents involving improper use of hoist and their cables. Firstly a clarification was made on the difference between hoists and winches. Hoists operate in a vertical environment such as with helicopters while winches operate in a horizontal environment such as on a vessel. Examples of what can cause miswraps and fouling were discussed. Some of the testing of hoist such as for lightning strikes was presented.
