AIR RESCUE REPORT

International Commission for Alpine Rescue

October 13-17th, 2015 - Killarney - Ireland

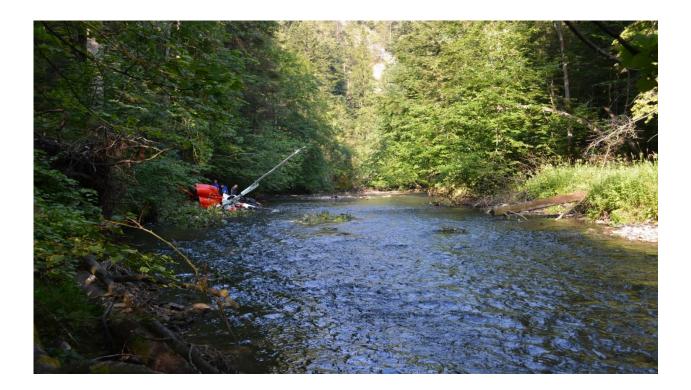
AgustaWestland 109- HEMS response for young child that had fallen with extremity and possible head injury. Hoist rescue was anticipated due to terrain. Landed enroute to pick up a local mountain guide. Aircraft struck wires shortly after locating the scene. 4 fatalities (pilot, HEMS crewmember, Doctor and mountain guide). Location of wires was known to company personnel.

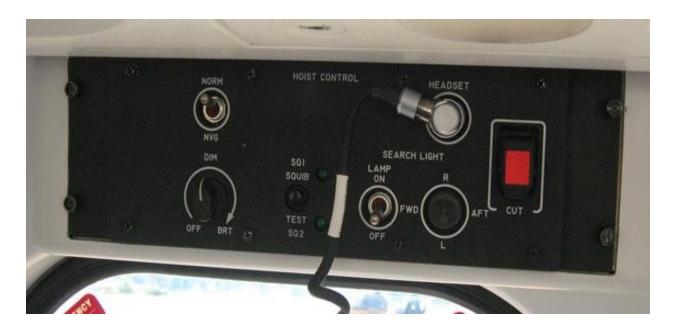
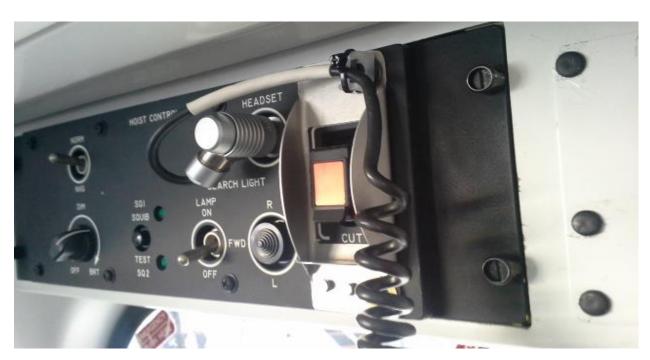
AgustaWestland 139 - During a night time training evolution the hoist operator was manipulating the searchlight that was next to the covered cable cut switch. The bridge of his finger raised the shear cover allowing his finger to activate the cable cut. Maryland State Police work with AgustaWestland to develop a guard for the cable cut switch and implemented a policy that the hoist light is not be used a search light during hoist operations.

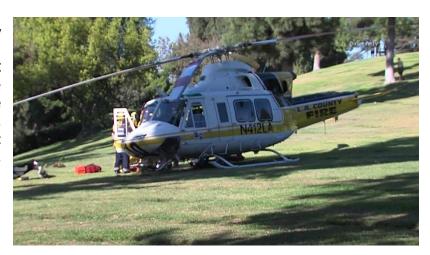
Bell 412- While performing HELOC during a wildland fire mission the aircraft experienced a dual engine failure with three people on board. Emergency landing with significant damage to aircraft and 1 minor injury.

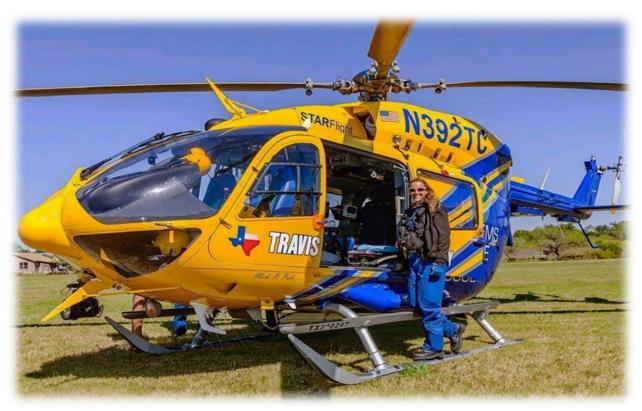
Airbus EC145- After a 20 minute search for a missing/injured hiker *STAR* Flight was requested to extricate the victim. The insertion was uneventful. During the extrication a slow spin started. The crew initiated forward airspeed. As the spin stopped the flight nurse was observed to be riding lower than normal and then fell.

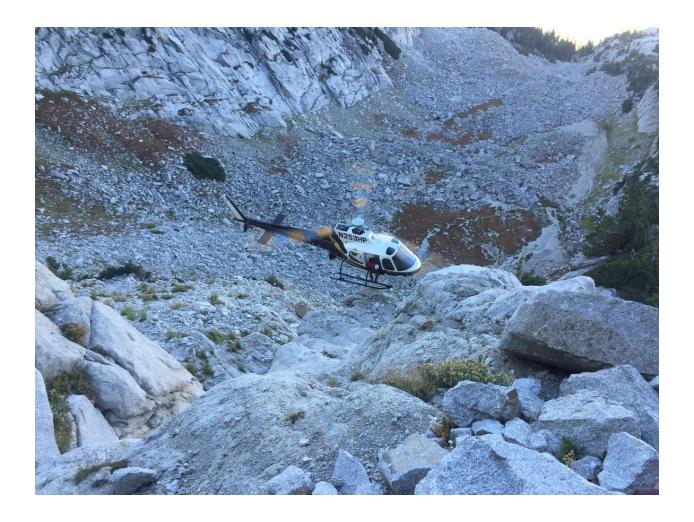
Airbus AS350B3e- Night time search for missing hiker. The night crew was unable to locate the hiker and stopped search around 0300. In the morning a new crew started the search and located the victim. Multiple one skid operations were performed to insert the ground rescue team.

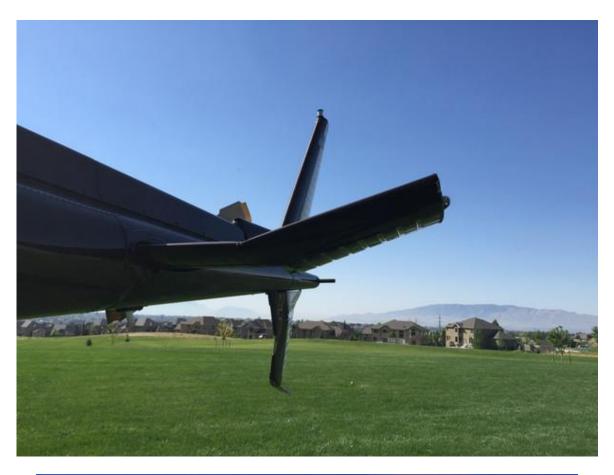
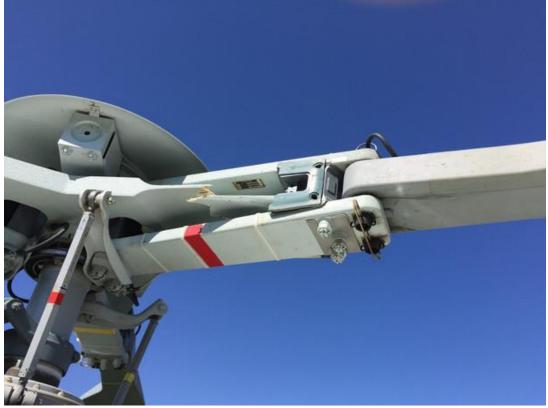
The victim was deceased but a decision was made to remove the body by helicopter. The victim was $\frac{1}{2}$

lowered by rope to the extrication area.

The helicopter approached and established a one skid hover. As the rescuers moved the victim (lowering lines still attached) toward the helicopter the lines were pulled into the main rotor. The pilot was able to fly away but there was substantial damage to the helicopter.
