2016 AIR RESCUE REPORT to the Mountain Rescue Association

International Commission for Alpine Rescue

**October 19-22, 2016
Borovets, Bulgaria**

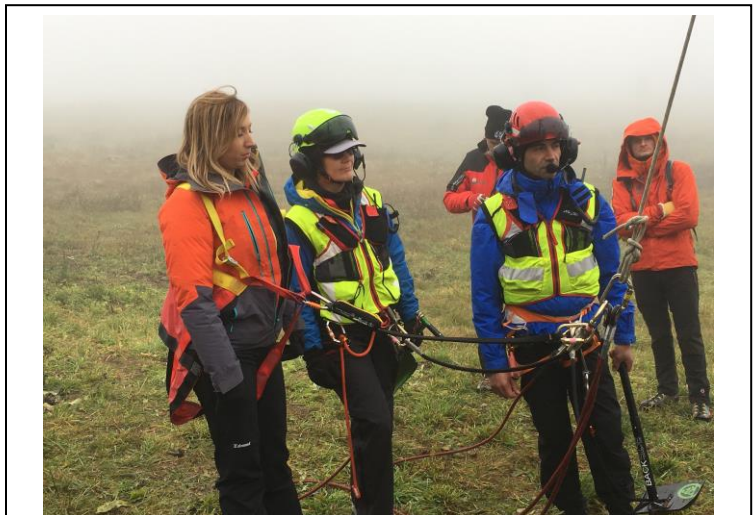
USA Terrestrial Commission Alternate Delegate Dr. Alison Sheets (center) during a simulation of the fixed longline avalanche rescue technique

The pre-conference on October 19th included a demonstration of a technique during which rescuers are inserted to an avalanche accident by longline, yet remain attached to the helicopter while it hovers overhead. The objective of this technique is to enable a rapid extrication of the rescuers from the scene in the event of a second avalanche. A few teams in Europe utilize this technique, which should largely be utilized by programs that can be airborne from their rescue base within minutes of an avalanche accident. This is a high risk technique, and the survivability of the subject(s) must be weighed against the risk of the operation.

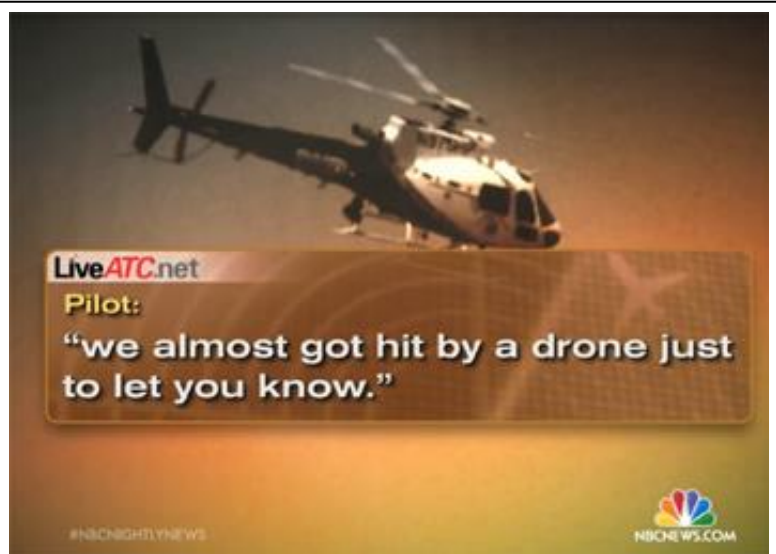
A HEMS helicopter in Fresno, California (USA) had a near miss with a drone in 2016.

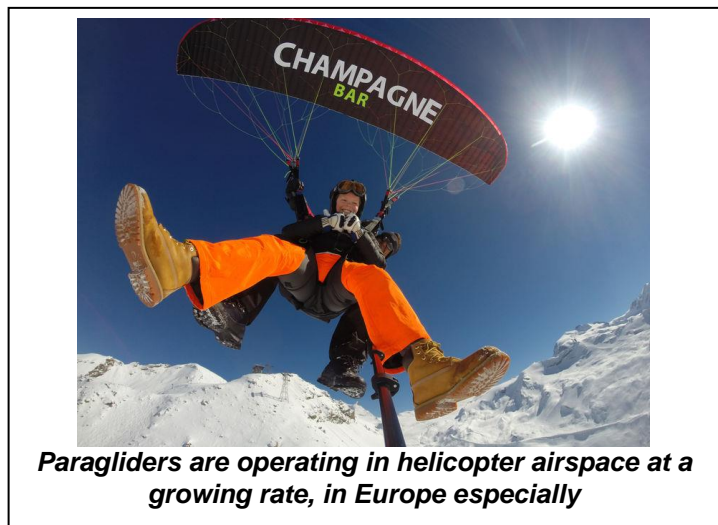
Paragliders are operating in helicopter airspace at a growing rate, in Europe especially

An AW 109 inadvertently came in close proximity to a paraglider on a final approach. This resulted in a partial collapse of the paraglider's canopy on one side. There was no impact on the helicopter.

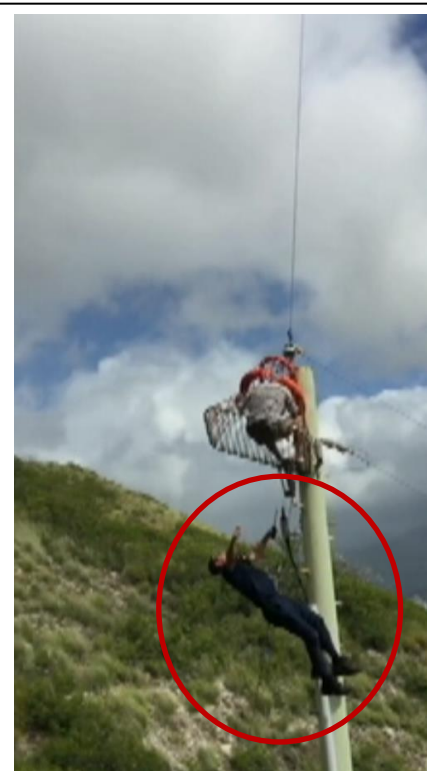
Firefighter falling from Rescue Basket during short haul operation in Hawaii.

Assisting a hiker with a medical emergency, rescuers loaded the patient into a rescue basket.

The basket contacted a utility pole, causing the firefighter to fall 30 feet. The patient remained in the basket and was transported to a landing zone.

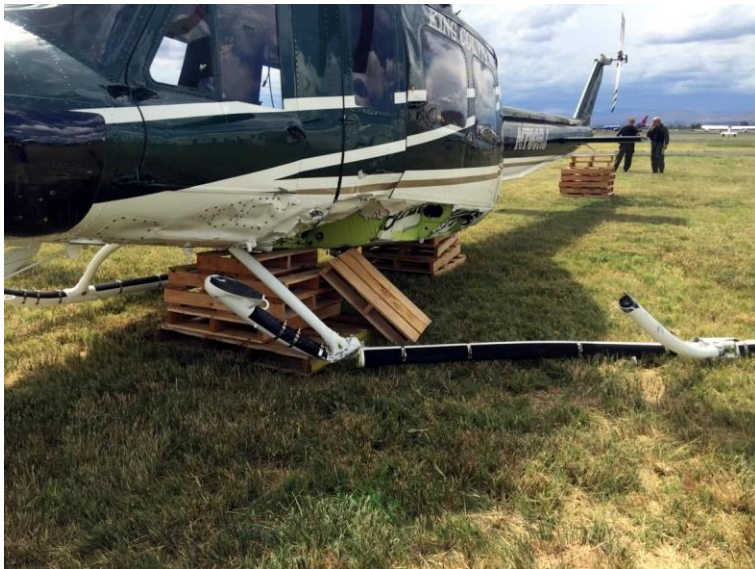
Damage to the King County Sheriff's helicopter sustained during contact with the ground. Pallets were arranged at a local airport to allow for a safe landing with damaged skid.

After one and a half spins, the helicopter impacted the ground, bounced back into the air, and continued with a straight and level flight away from the mountain.

Firefighters arranged wooden pallets to balance the damaged helicopter on landing.

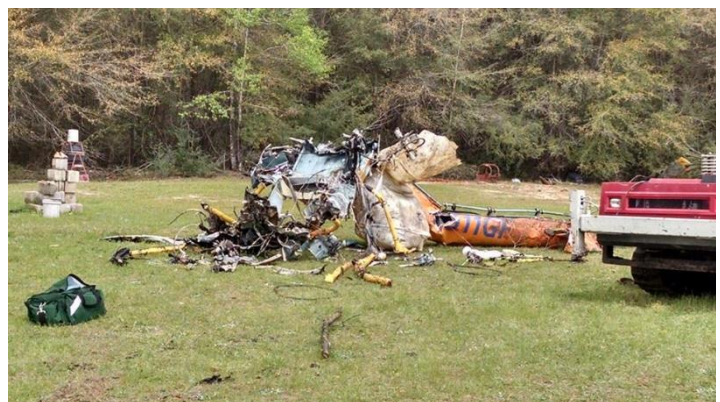
The wreckage was heavily fragmented with only the aft fuselage being generally recognizable.

The LifeFlight Communications Center did not receive its normal 15-minute check-in. Satellite tracking showed the helicopter was still at the LZ, which they knew to be incorrect. The wreckage was eventually located in a swampy, heavily wooded area. The wreckage was heavily fragmented with only the aft fuselage being generally recognizable.

The engine and transmission were separated from their mounts. A 10 by 20 foot crater was present. The debris path exhibited a 45-degree descent angle through trees. 80-100 foot trees exhibited impact damage and evidence of blade strikes.

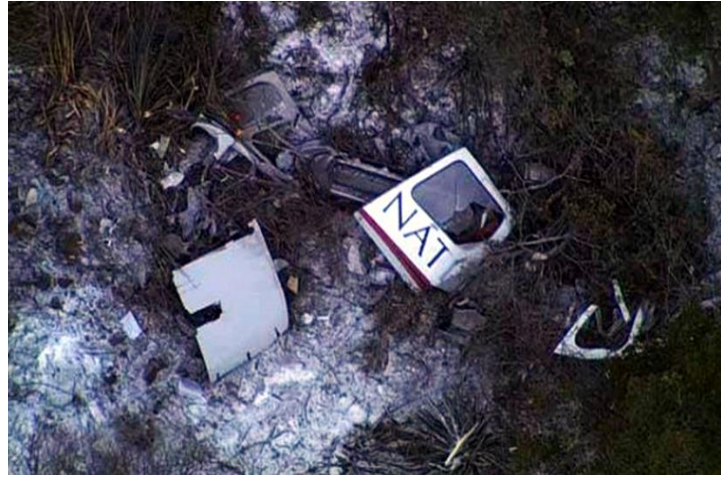
A paramedic survivor of this accident attempted lifesaving measures on one of the victims who showed signs of life, but was unsuccessful.

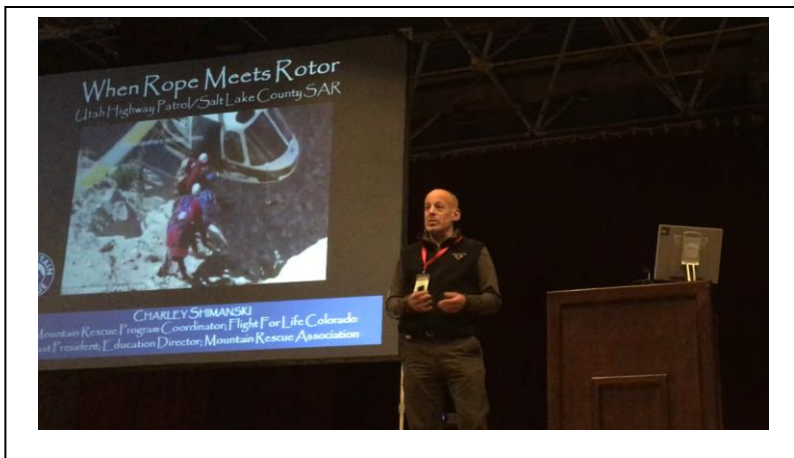
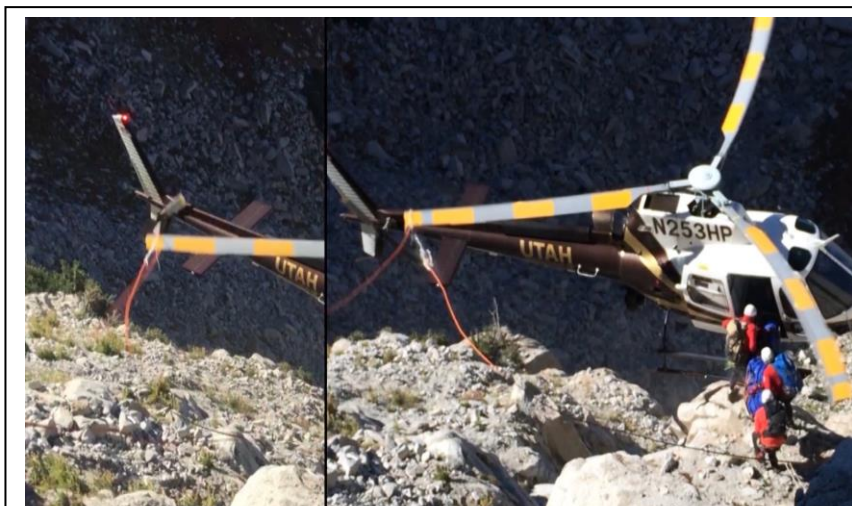
The pilot was attempting to perform a one-skid load of the deceased hiker with the help of several rescue team members.

One of the recovery team had secured himself to a rope that was anchored above the tip path plane of the helicopter.” While the rescuers approached the aircraft to load the litter, that rope – still attached to the terrain above – was pulled taught into the plane of the rotor disk, and was caught by the main rotor blade – ten inches from the blade tip. The rope was then pulled rearward by the main rotor blade and made contact with the tail rotor. The pilot did an extraordinary job of maintaining control of the aircraft and maneuvering away from the rescuers on the ground. He regained control, and then made an emergency landing at a lower altitude.
