AIR RESCUE REPORT

International Commission for Alpine Rescue

October 19 - 22, 2011 – Åre, Sweden

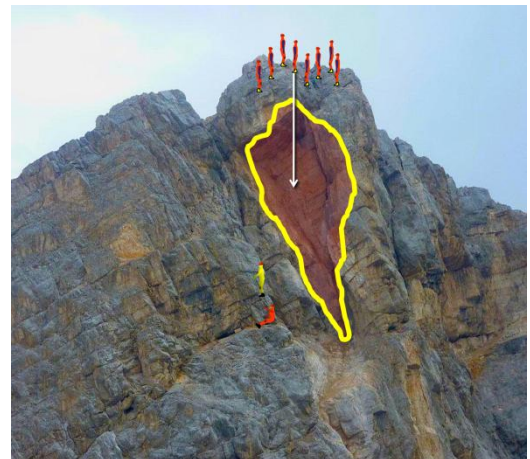
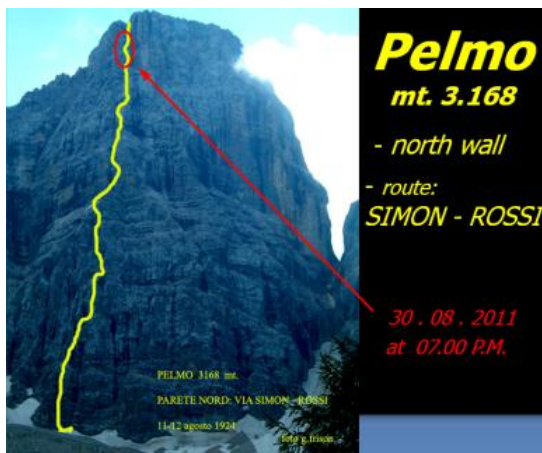
Italy, Rockfall

This is a very tragic accident. It was not an aircraft incident but is recounted here because unsuccessful attempts were made to insert a rescue team with a helicopter. Two climbers were stranded near the top of the North wall of Pelmo in the Dolomites. After climbing the Simon Rossi route, one of them sustained a leg injury within 100 metres of the summit and they were unable to continue. Bad weather precluded inserting rescuers at the site or at the top with a helicopter. At nightfall, a rescue team climbed the normal route to the summit and two rescuers were lowered towards the injured climbers at 5:05 AM. As they began the descent a massive rockfall occurred at the summit with an estimated 3000 cubic metres of rock. Both rescuers were fatally crushed. Their remains were recovered near at the base.

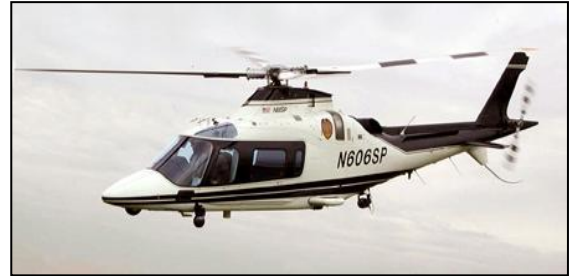
United States (New Mexico) NTSB ACCIDENT REPORT RELEASED

The June 9, 2009 accident (*reviewed in 2009 IKAR Air Rescue Report*) resulted in two fatalities, when the New Mexico State Police Augusta A109E crashed during a rescue in the Pecos Wilderness (Santa Fe National Forest) near Santa Fe, New Mexico.

The NTSB published the probable cause as, "pilot's decision to take off from a remote, mountainous landing site in dark (moonless) night, windy, instrument meteorological conditions." More significantly the report listed the following contributing factors;

- An organizational culture that prioritized mission execution over safety
- Pilot's fatigue, self-induced pressure & situational stress
- Failure to conduct mission risk assessment

"NMSP personnel did not regularly follow the SAR plan.... and did not routinely communicate directly with SAR commanders during SAR efforts. This reduced the safety of SAR missions."

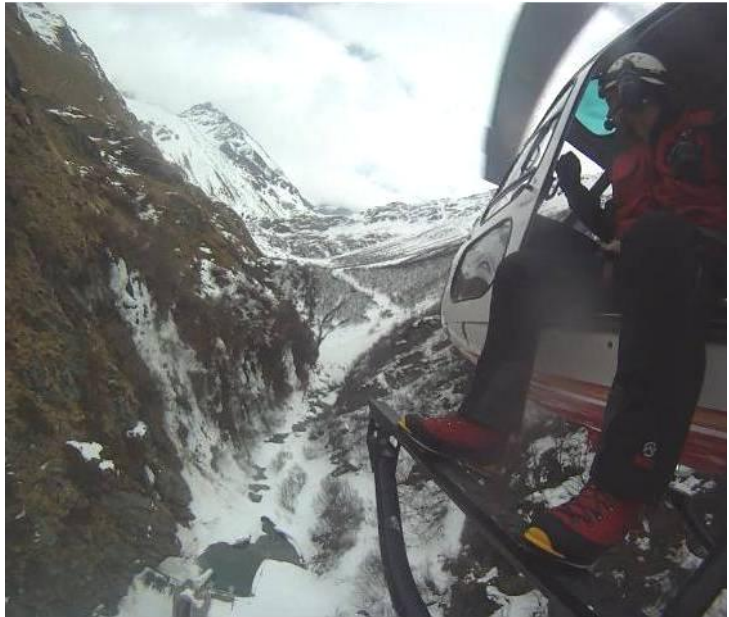
Swiss rescuers responded to a mass-casualty incident following an avalanche in the Vallon de Valsorey on March 26, 2011. Eleven touring skiers were involved in the incident with ten persons buried. There was confusion with the exact location initially due to other recent avalanches being visible from the air. The objective dangers encountered at the site included deep snow, overhanging slopes not cleared, no emergency exit, narrow valley and flight traffic involving 11 helicopters. Additionally there was confusing information about engaged forces by Dispatch Center 144.

Difficulties encountered with incident communication included; rescue channel overloaded, no mobile phone coverage, no visual overview of avalanche site, prioritization of air traffic communication and German-French language barrier.

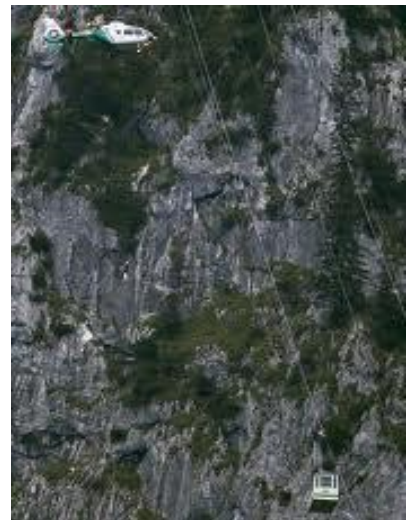
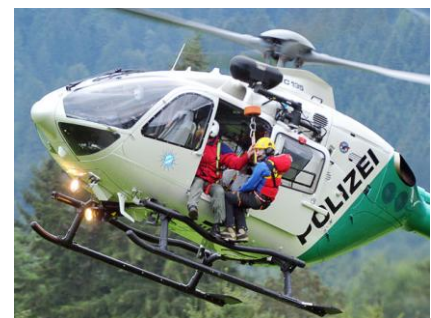
Germany- TEGELBERG GONDOLA RESCUE (Klaus Opperer)

On August 12, 2011 these rescue techniques were put to the test during a complex rescue on the Tegelberg Gondola, which is on the Tegleberg Mountain near Schwangau in Southern Bavaria. The gondola route is 2,146 meters (7,404 ft) in length and rises to 1,880 meters (6,170 ft). After a tandem paraglider flew into the cables, operations had to be temporarily stopped. The paraglider and instructor pilot were immediately rescued by helicopter, however the removal of the paraglider chute proved to be problematic. The material was hopelessly entangled with the wire rope. This required a complete evacuation the entire gondola system. 132 people were flown from the top station back down to the valley employing numerous helicopters. 30 passengers in the lower gondola had to be lowered by rope from a height of 70 meters (230 ft), an operation lasting into the evening. 19 passengers and the cable car operator in the upper gondola could not be rescued by helicopter until the morning of 13 August due to strong winds. Although the upper gondola was 80 Meters (260 feet) above the ground, it was in exposed terrain which was unsuitable for lowering the passengers. The rescue was completed at daybreak by helicopter hoist.
