# AIR RESCUE REPORT

International Commission for Alpine Rescue

# IKAR-CISA

**October 17-20, 2007 - Pontresina - Switzerland**

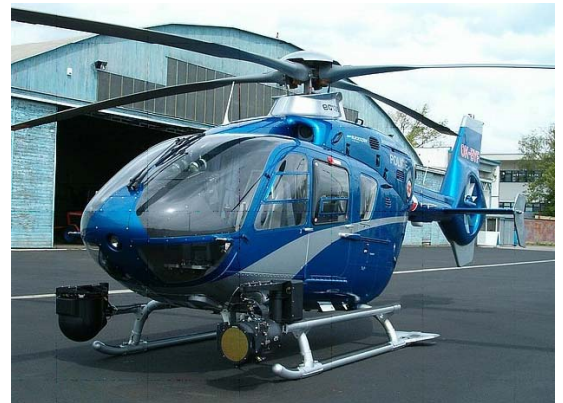
### **Fadec Failure Czech republic**

EC-135- FADEC problem- one engine shut down in-flight. Although currently under investigation this incident, “very rare” is considered to be “technical” in nature. Subsequent investigation showed diode failure in FADEC resulted in “overspeed” indication and FADEC shut down engine.

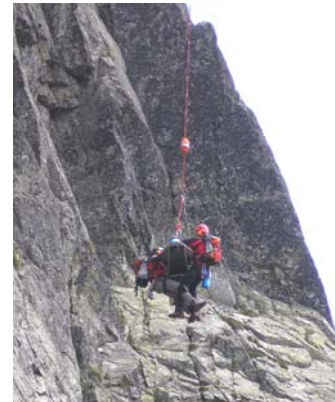
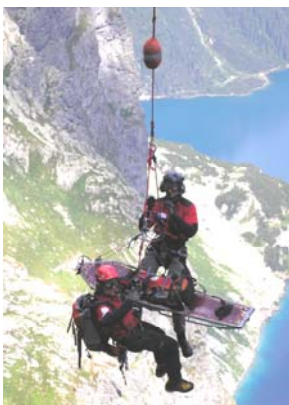
### **Option 2 – Wall Rescue Technique**

It is applied for wall rescues when the victims are below the summit or a convenient place for rappels from helicopter, but in the range of climbing ropes (max.50-60 m below the summit or descent site). Usually four persons are required to apply this technique. The rescuers are dropped off in a convenient site and access the accident site by rappel. Rescuers and victims are then evacuated using the HEC technique.

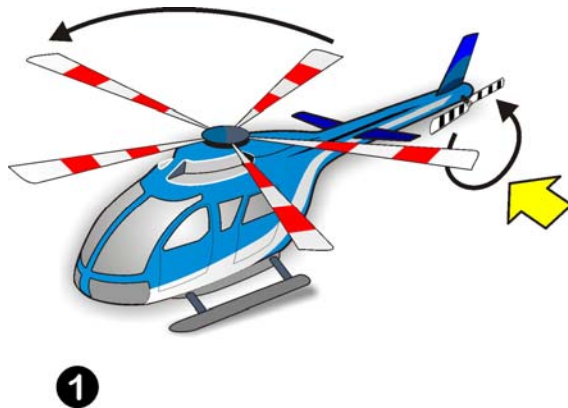
**Bell 204  
Robinson R 22**

- Main rotor counter clockwise (anti-clockwise)
- Power pedal- Left
- Tail rotor is pushing

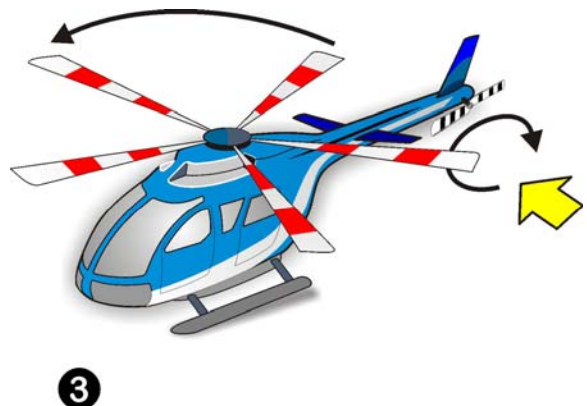
**Bell 206 / 407 / 430 / 427 / 230  
Agusta 109 / 119**

- Power pedal- Left
- Tail rotor is pushing

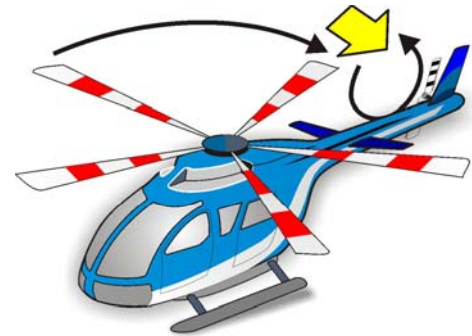
### Eurocopter SA 315 / SA316 / AS350

- Power pedal- Right
- Tail rotor is pushing

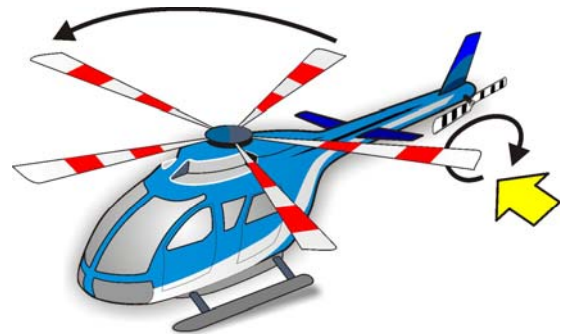
### Eurocopter EC 145 / BO 105 / BK117

- Power pedal- Left
- Tail rotor is pushing

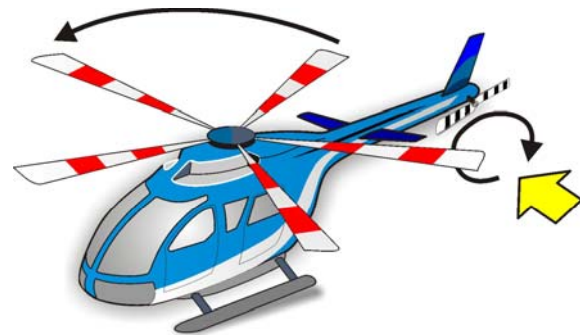
### Robinson R 44

- Power pedal- left
- Tail rotor is pushing turning clockwise

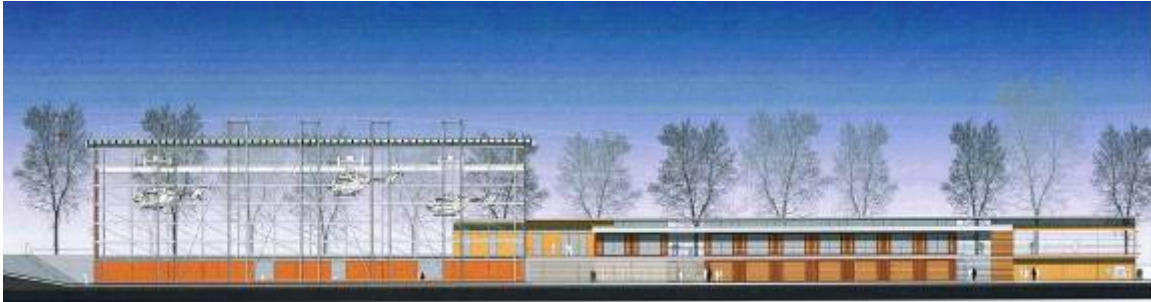
A former military barracks area has been obtained as a site for the training facility. Old helicopter fuselages have been obtained for retrofitting into simulators at the facility. As part of the research phase these fuselages were suspended from a crane to test possible configurations and training heights.

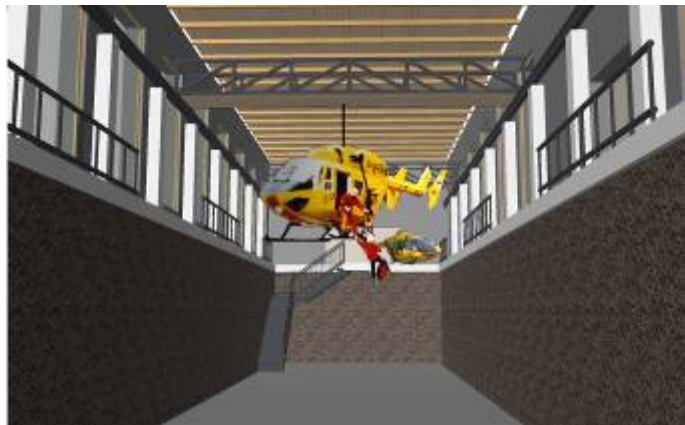
Within the training facility itself a fuselage will be suspended on an overhead crane system, which will thereby permit movement in a simulated three-dimensional mode. There are several simulator stations which are being developed to permit varying cabin familiarizations.

The air rescue training facility has been designed to have a high degree of realism in the training simulators. The helicopter fuselages will have a turning tail rotor of constructed Styrofoam to highlight hazards. The effect of sun flicker through main rotor blades will be simulated to create realistic field conditions.

Huge mounted fans will create downwash below the simulators, which will be combined with aircraft noise for realism. The simulators will have rescue hoists with realistic cable speeds which will enhance familiarity with the equipment. The research and design phase determined that suspending the helicopter simulators at 12 meters would place them at a height, which is above the “fun factor” level for participants and cause them to treat the experience more seriously.

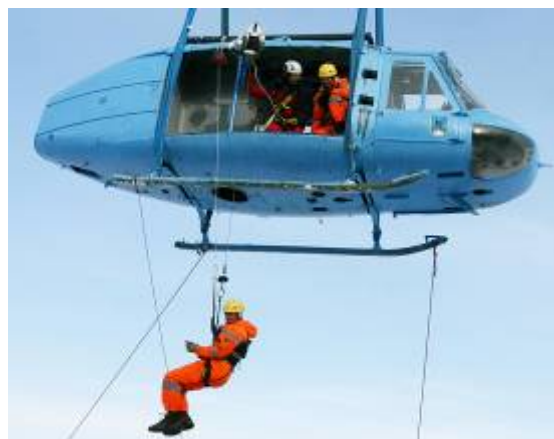
Additional simulator stations include an artificial climbing wall for both helicopter rescue training as well as climbing training. Due to the increased frequency of flooding incidents within

Germany there are plans for a water rescue station, which involves a pool and an adjacent building to simulate rooftop extractions.

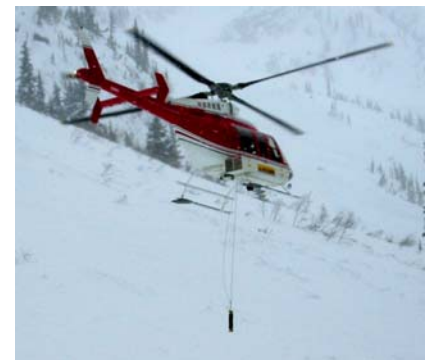
Techniques for using the system manufactured by Girsberger Elektronik AG for beacon searching was discussed. The following recommendations were made.

- Shut off all other external radio channels- distraction factor
- Turn off the transponder close to the ground- interference factor
- Only open the doors to lower the antenna
- Transceiver on hot mic
- No other mics on hot-mic!!!!!!
- Intercom volume not higher than approximately 2/3
- Pilot changes volume level himself
- Fly search pattern across the avalanche path from bottom to top- 150 M search strip width (across avalanche path)
